Historic Building Conditions Assessment
Meredith Public Library
Meredith, New Hampshire

Norman E. Larson, AIA

April 24, 2012

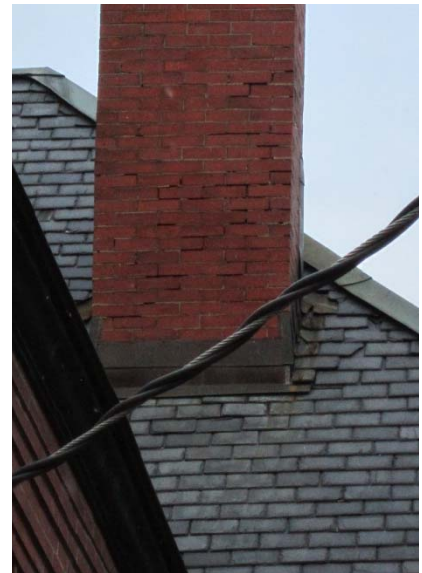
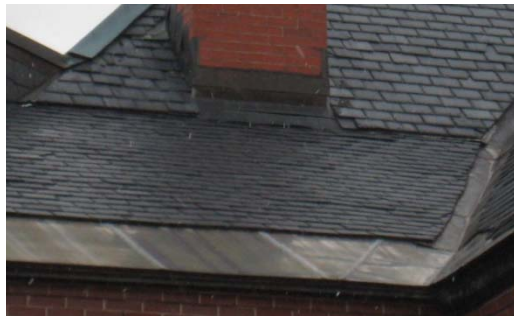
The slate roofing on the Benjamin M. Smith Memorial Library was altered during the construction of the 1988 addition to allow for the installation of ridge and hip vents. The existing slate is generally in fair condition with the exception of a few areas visible from the ground. The greatest area of localized damage appears to have occurred near the two chimney bases, either from ice issues or from foot traffic on the roof occurring during inspections and/or in maintenance of the chimneys. After chimney masonry repair work discussed below is complete, damaged slates should be removed and the area repaired with new slate to match the existing. Considering the apparent age of the slates, the library should have the slate roofer conduct an inspection of the entire roof every year or two so that missing or damaged slates can be replaced before water damage can occur within the building envelope. Areas of concern include the roofing near the skylights in the Children’s Room, along the hip vents at the south side of the building and at the main roof below the drip-line of the entry pavilion roof eave.

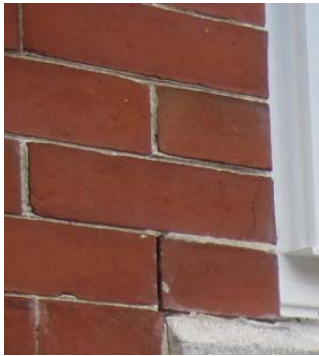
issues with the mortar. Re-pointing the existing masonry on the south side of the building and on the chimneys on the west side of the roof have previously been identified as maintenance needs of the library. Work on the historic exterior of the library should be done carefully to maintain the health of the building. Given the date of the c. 1900 construction of this library, care should be taken to match the composition of the mortar used for re-pointing as well as the installation of the new materials. Most of the damage to the existing mortar comes about as a result of water entering the building system at the granite window sills and leaching back out of the wall through the masonry below. The color of the new mortar should also be matched to the existing as part of the analysis of the existing materials.

The bricks used on the library should be protected during re-pointing by limiting what types of power tools can be used for the removal of mortar, which should be removed to a uniform depth of about 1" deep. New mortar should be struck to match the convex profile of the original work and care taken to insure that the joints are not overfilled in relation to the characteristic rounding of the existing bricks edges. It is better to hold the mortar back than to overfill the joints. If the work is properly done, there is no need to re-point entire facades of the building (as is commonly done to mask the differing mortar work of individual projects).

Much of the south wall will need to be re-pointed. Both chimneys should be re-pointed rather than removed or replaced. Contractors who cannot match the mortar profile of the original masonry should not be considered for re-pointing work.

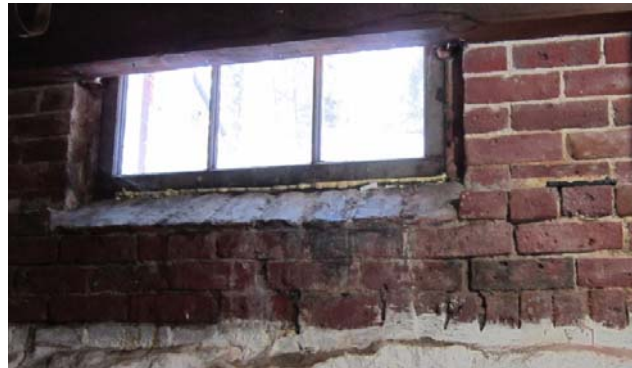
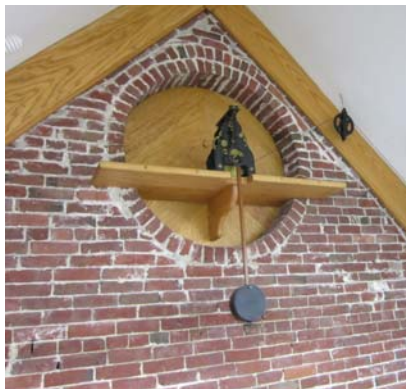
At the building interior, there is also some masonry repair and re-pointing work to do. At the basement level, water movement to the interior has weakened and spalled mortar work under windows (or the places windows used to be) in the south wall and also generally at the north and south walls of the area under the staff work room. The room previously used for costumes may also benefit from some attention, especially at the north east corner.

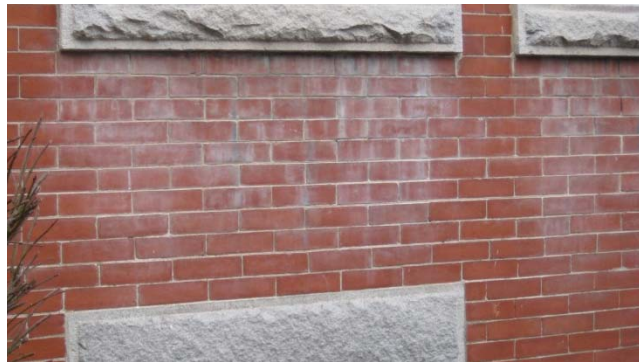
The brick masonry on the Benjamin M. Smith Memorial Library requires two different types of cleaning at the building's exterior masonry. Most visible from the street is the efflorescence of salts from the brick mortar in areas underneath the sills on the front (east) and south facades of the building. This type of staining also occurs in several places near the building eaves and is caused by water getting into the masonry wall system and leeching the salts from the mortar as the water makes its way out to the exterior surface. Once out, the water evaporates from the wall surface, leaving the salts behind. The common occurrence of this type of staining at the eaves suggests an inspection and minor repair of the drip flashing is warranted. The more readily noticed efflorescence under the window sills is common and related to the failure of the joint between the granite sill and the brick. Sealing between these dissimilar materials is a common problem. The joints should be raked out and sealed with an appropriate caulk instead.

Surface efflorescence may be cleaned by a qualified mason once all potential entry points of moisture have been closed. This effort should be successful. Rust staining at the locations of the original downspouts (which were removed previously) may be targeted for removal as well; though this solution will likely not result in complete eradication of the old stains, their visual impact may be reduced. Similar iron and rust staining has occurred on the granite entry stonework and landscaping steps in areas where railings are set in the stone or large metal objects (urns?) previously adorned the stair sidewalls.

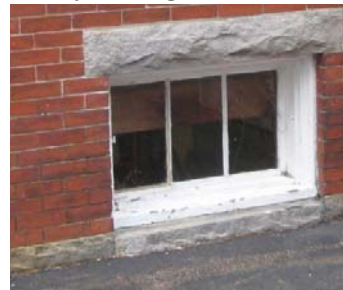
tight and the stones show little sign of movement. The rear block foundation is also of stone but quite low to the ground and without the dressed margins. This area of the foundation

is subject to additional splash back, especially as both the south and west sides of the building are paved right up to the foundation. This rear part of the foundation should be re-pointed and the joint with the brick masonry above caulked. The extra water impacting the system here is the likely cause of the mortar damage at the building's interior behind the stone.

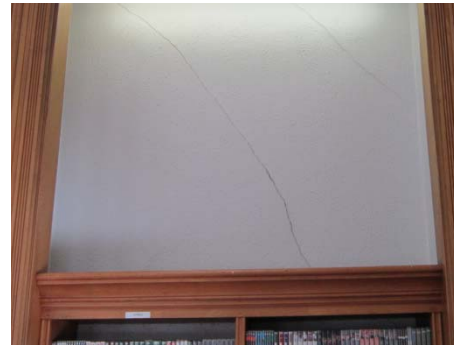
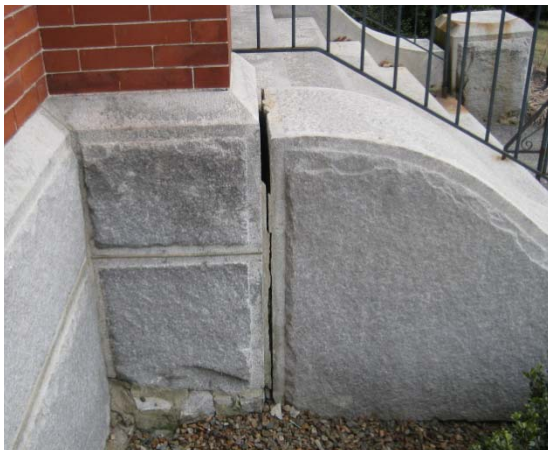
Interior cracking of plaster above recessed bookcases at each side of entry, including what appears to be a shifting of plane in the north side wall, indicates uneven settlement under this part of building. A further indicator of this may be the top piece of the brick entablature at its terminus with the entry pavilion, which appears to have shifted outward approximately ¼". The granite steps at original entry have also shifted. Buildings move over time and such movement is not always of great concern, but the extent of the recent movement leads to a search for ways to reduce any future movement.

The building is at the top of a hill rising from the street, and the pedimented entry pavilion focuses rain water at each side of the entry. The stairs should be removed and re-set true and tight to the Library. The lowest step has fractured at the location of bottom rail post, likely as a result of freeze/thaw action of water leaking in around the post. Do not replace this step during restoration work. Instead, support fully both the step and the fractured piece and caulk the two pieces together at the top only. At the time the stairs are pulled away from the building, perimeter drains should be installed around the three sides of the entry pavilion. These should drain to daylight or preferably into the storm drains in the street.

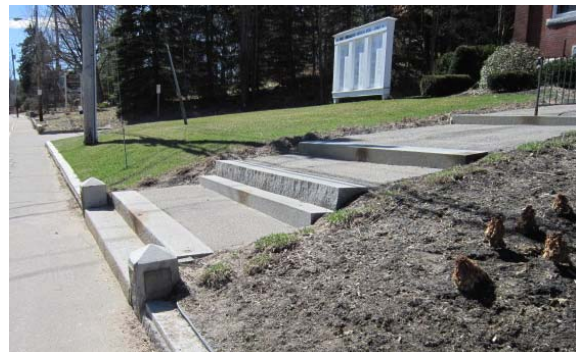
Site stonework has been subject to ongoing frost and water movement which has resulted in raising or rotation of walkway stone steps and some shifting of the high stone curb between the grassed front lawn area and the sidewalk along the street frontage. While the rotation of the curb is noticeable, it is not dangerous as the shifting walkway stones might be. These stones create a trip hazard wherever they are raised more than ¼" above the walking surface along the path of travel. These should be reset, or the walkway re-built to match their height. The repair of the granite steps at the original main entry will require the complete

removal of the existing stairs and their reassembly. Additional work identified elsewhere may require excavation and trenching in order to upgrade the water service to the building from the street and to drain away water from the new perimeter drain. While the need for repairs to the site stonework might allow for delay, the other work required on the site and the economics of not tearing the site up twice points to doing all of the identified site work at the same time. The existing park-like setting should be maintained, but this might be a good time to re-build the entry steps and walk coming to the old front door

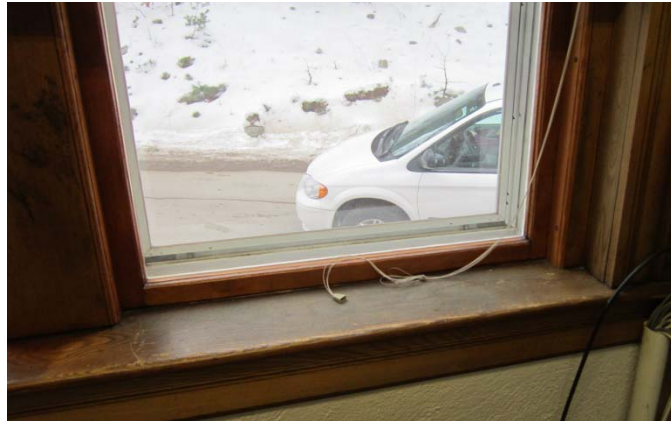
The single-glazed historic double-hung windows on the main level have reportedly been recently repaired and put in better working order with spring balances replacing the sash weights. The repairs did not apparently extend to refinishing window sills as water damage is present at windows at the sill of south facing windows in the Library Director's office and the Staff Work Space. The west window of the Work Space is also in need of some

repair following the removal of the original bookcase to its south. Damaged window sills should be sanded down by hand to bare wood and along with any new wood, finished with a clear urethane finish. If the library does not have any record of testing the interior clear finish (varnish) for lead, this should be accomplished before proceeding with any sanding of such finishes.

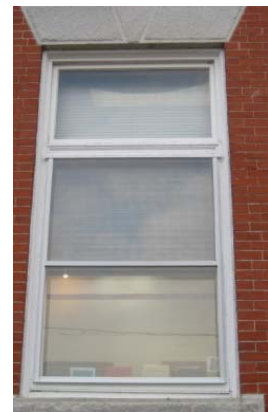
The exterior of the windows, with the possible exception of the first floor sashes themselves, are in need of scraping and painting, especially within the enclosure of the storm window units, though these areas are protected by the storm windows to some degree. The awning windows of the basement are in the worst shape of any windows exposed to the weather with bare

wood commonly visible through failing paint on the sills and some of the jambs. A comprehensive program to remove, inspect, and repair the existing storm windows should be undertaken at the time the windows are prepped and painted. All of the joints between the wood windows and the adjacent masonry should be raked out and caulked at the time of repainting.

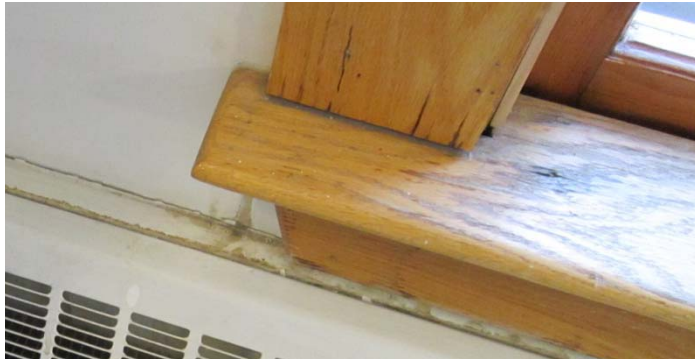
One of the windows of the addition has had some water issues which are thought to be related to a roof window above which has now been removed. This window is in the main stair hall of the addition just outside the door to the Young Adult's Room. The sills and side trims of this window need to be repaired and repainted. Once the refinishing is done, this window should be watched for additional

water damage as it quite possible that all of the water problems that caused this damage may be unrelated to the removed roof window.

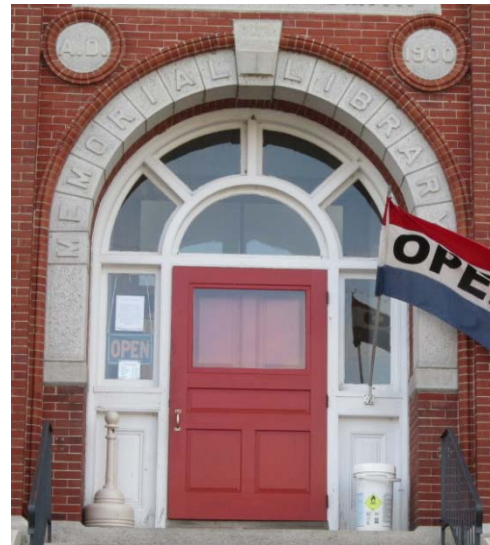
The existing six panel entry door is a replacement of the five panel door original to the building entry. The door is still in common use, but most library patrons use a new entry door in the addition from the parking area to the rear of the library. The door is in very good condition, but it and the storm door paired with it could use some minor repairs which could improve the energy efficiency of the library.

These two doors should work together to prevent air infiltration and reduce heat transmission through the closed opening. The entry door is fitted with metal weatherstripping which is failing and/missing at the strike side of the door. The weatherstripping should be repaired and the door kept closed, especially during the coldest season of the year. The outer storm door has a closer, is lighter, and lets in more natural light and is often the only door that is closed. The weatherstripping on this door should be replaced as it is failing at the hinge side of the door and gapping at the upper strike side of this door. The lightweight door is glazed in its upper portion with single paned glass which is all this door will carry. A replacement door could be fit with insulated glazing.

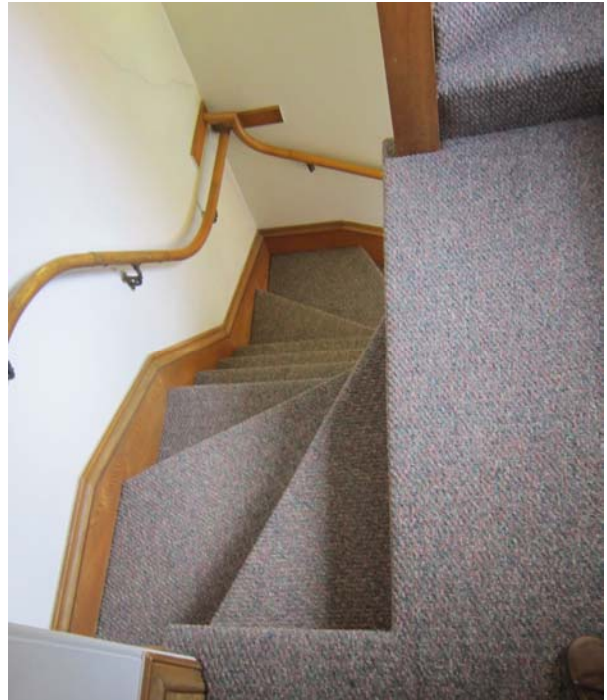
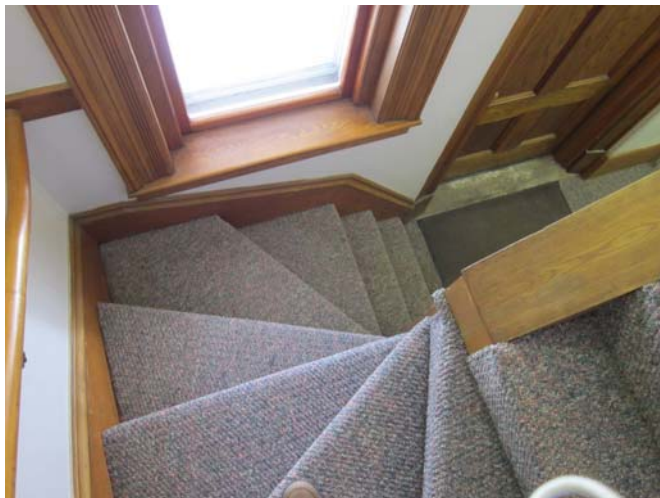
The back stair of the Benjamin M. Smith Memorial Library is original to the building and is the designated second means of egress from both the upper floors of the library and from the basement level. The winding stairs are of wooden construction and are composed of steep winders and short steep straight sections connecting narrow landings. The stairs do not meet current building codes and actions should be taken to bring the existing stairs more closely into compliance. They are both too narrow and too steep by current standards. This is an opinion expressed also by the local fire chief and the State Fire Marshall who suggest that adding sprinklers to both of the two stairwells in the building would extend the time people would have to get out of the building and make the non-compliant stair acceptable (or acceptable enough).

The relative steepness of the stairs poses a risk to people hurrying on the stairs to reach the exit level. Adding new guardrails at the center of the upper portion of the stair would

eliminate the potential of an eight-step fall. Strategically adding railings to the interior of these guardrails could shift the path of travel away from the center of the winders and further reduce the chances of a fall. The stairs are narrower at some points than at others and as long as the railings and guard rails do not reduce the stairway width to less than the current narrowest width, the capacity of the stairway should not be reduced. The narrowest portions of the existing upper stair are 27” wide. The wooden railings on the outside wall

are not continuous and should be made to be by adding additional lengths where no railing is provided. The railings should extend across the window openings to provide the code-required continuous railing. Windows in the stairwell pose an extra hazard in the stairwell if any of the glass is not tempered because of the increased potential for a fall on these steep stairs. Any float glass in the window units should be replaced with tempered glass.

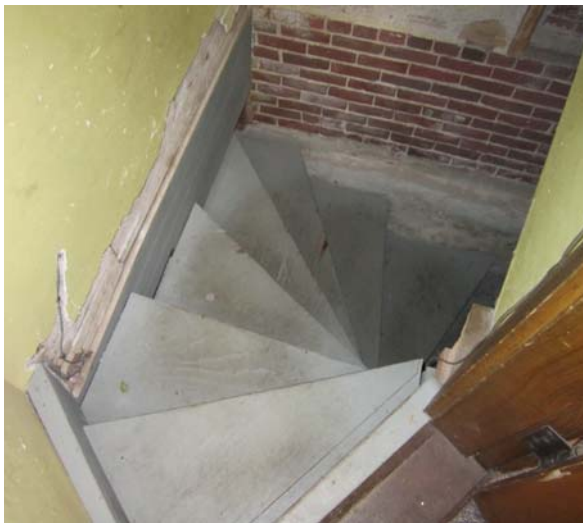
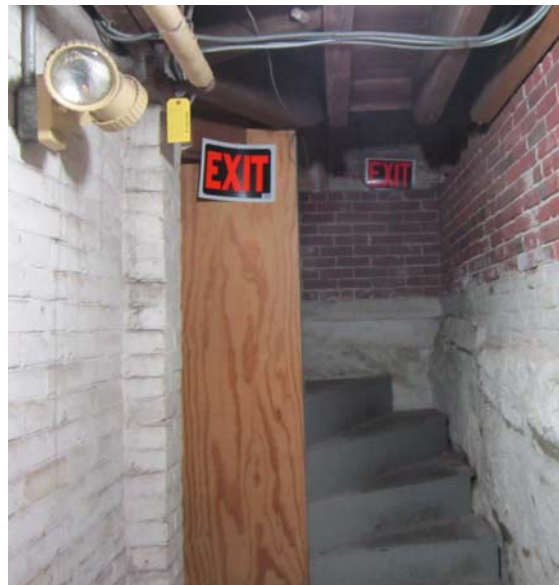
The stairway up from the basement poses some additional challenges from a fire safety point of view. These stairs were re-built in modern times with pressure treated framing and plywood construction. The fundamental problem is the lack of a fire rated enclosure around these stairs. The furnace room adjacent is a potential fire source and there is no fire rated separation between the mechanical space and the basement egress stair. The openness of the

existing partition is evidenced by the amount of daylight from the furnace room that shines into the existing enclosure. Because the basement stair is not in a fire rated enclosure, there is similarly no fire separation between the basement stair and the egress stair above. The existing basement stair will need to be removed in order to finish the interior side of the stairwell wall with an appropriate fire rated assembly. This would be an ideal time to address repairs to the structure required for the upper part of the stairway, including better support of the central wall. It will

also be necessary to patch interior finishes of the stairway above closing pathways for fire spread through the stair. The rebuilt stairs within the enclosure may not be any wider or more code compliant than the existing stairs, but would be much safer. The door at the top of these stairs is too narrow but may not be able to be replaced with a wider door because of the organization of the upper stairway.

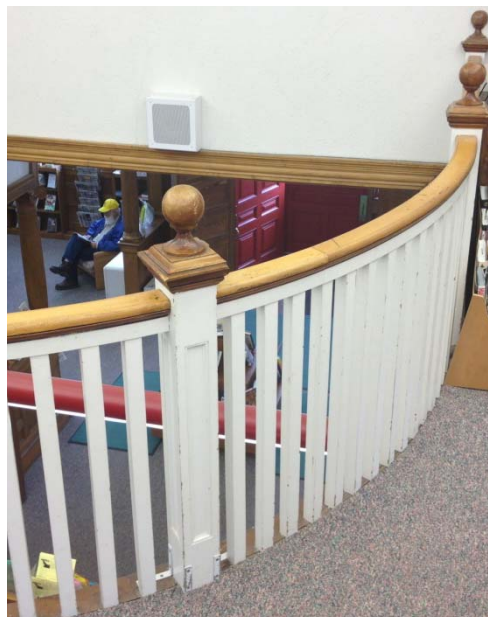
Current New Hampshire building codes require guards at least 42" in height in locations such as that found around the well overlooking the circulation desk. The historic railing extant at that location is only 32" high. The use of the room by juveniles and young adults suggests that this space might not be the place to overlook potential risk of a fall. It has been suggested previously to the library staff that the library address the potential fall issue while retaining important character-defining features. This might be achieved by removing the railing and reinstalling it on a new 10" high curb. The curb should be visually distinguishable from the historic curved elements. The paneled railing posts should be repaired and reset in their original configuration and preferably without the face-mounted metal brackets securing

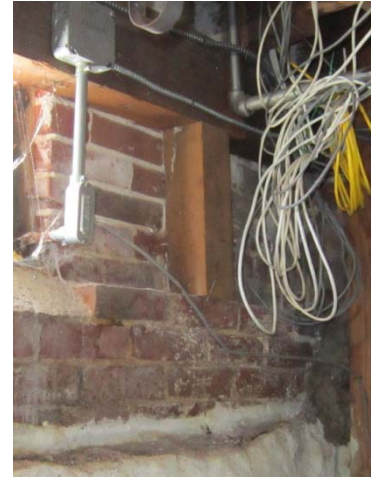
The Benjamin M. Smith Memorial Library was built prior to the advent of pressure treated wood. In several places original bearing has been affected by moisture and repaired with installation of new beams and structural elements. These include the beam pockets in the basement under the stacks and the north wall of the old costume wall. One support for this beam inside the room and one just outside the door are not carrying the load from the beam above. The loose framing should be modified to fit tightly and bear on pressure treated bearing blocks on all masonry and concrete surfaces. Not all areas of this type of bearing are open for visual inspection. Further investigation may identify other areas of the basement in need of this type of work.

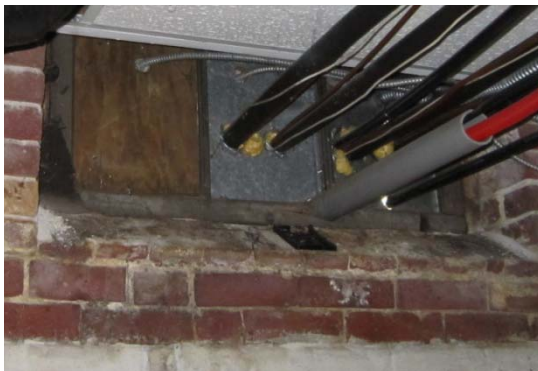
Mechanical room piping passing through infill panels at two south side window locations leaks air. Humidity of summer air and related condensation on masonry and concrete surfaces is likely the cause of deteriorating drywall finishes near floor. These leaks should be closed temporarily with appropriate sealants. Windows on this level should be kept closed. Once the humidity levels are controlled, damaged drywall should be removed along with any wood partition framing showing signs of mold. Coordinate the work in this area with other work such as sprinkler equipment installation; fire-rated ceilings, adjacent fire-rated stairwell construction and the potential installation of a new water storage tank.

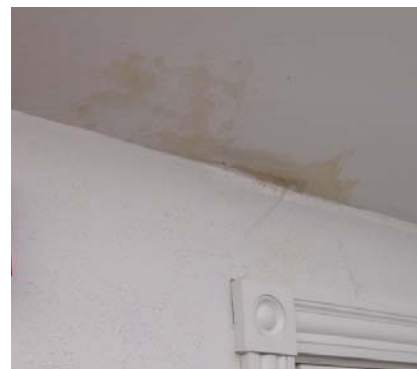
Water stains at the ceiling level beneath the attic and underneath the sloped ceilings beneath the roof framing are always concerning. Suspicious water stains were found on the walls and ceilings of the Children's Room and Young Adult's Room at the upper levels of the Benjamin M. Smith Memorial Library as well as the north reading room off the lobby. Additional water stains were found in the main stairwell and the ceiling of the office of the children's

librarian. Repairs to the roofs above all of these areas suggested elsewhere in this report should address the causes of these issues, but the effectiveness of the solutions should be watched over time by checking on the ongoing status of these leaks and their repairs.

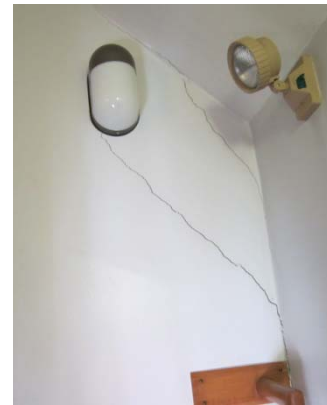
Vertical cracks at the corners of walls in the stairwell and in the work areas of the west wing are of greater concern than those mentioned above. These may be the result of shifting of the wall, perhaps related to the bearing on the wall and platform on the masonry foundations below. Any repair work to stabilize the wall bearings should be completed before repairs are made to the wall finishes. Once the work is accomplished, the repair should be examined semi-annually for a few years for signs that any wall movement is continuing. Any such finding would lead to a more aggressive investigation into the root cause of any such movement.

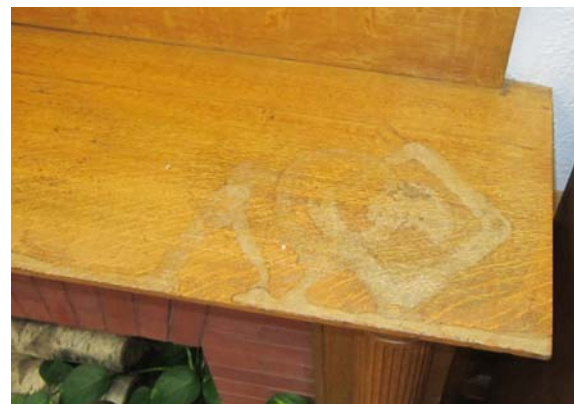
The main floor of Benjamin M. Smith Memorial Library has a good deal of decorative woodwork including decorative columns and pilasters on a low paneled wall in the colonnades on each side of the lobby, wood fireplace surrounds, paneled wainscots, built in cabinets and bookshelves, and baseboard and picture mouldings. Most of these materials are in good condition but a few localized areas or items could use some attention. Like the windowsills, some of the

mantle tops like that in the south reading room need to be refinished because of previous water damage. Damaged areas should be hand-sanded and refinished with touch-up stain if required and a polyurethane or paint finish to match the existing. One area to pay particular attention to is the at baseboard near the bookcase at the corner at north reading room

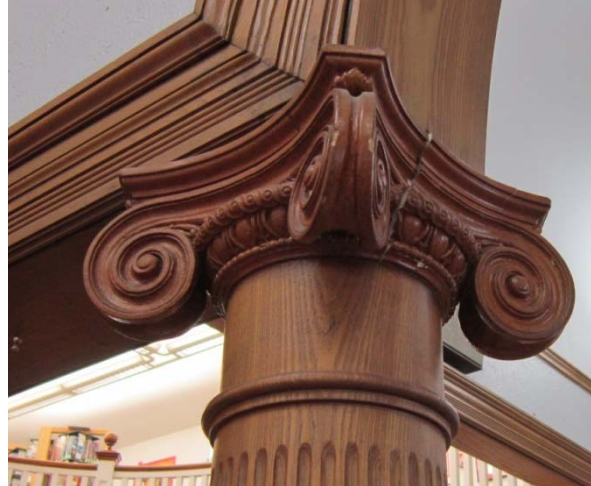
The south reading room has a picture rail moulding on the west wall that has popped and needs to be re-secured. The mantelpiece in the north reading room has a pecan wedged behind it which should be removed so that the mantelpiece may be re-secured to the wall. The wood band that is splitting at the well above the circulation desk may not be repairable, and the crack in the capitol of the southwest decorative column certainly is not. These defects should be stabilized and refinished to the greatest degree possible.

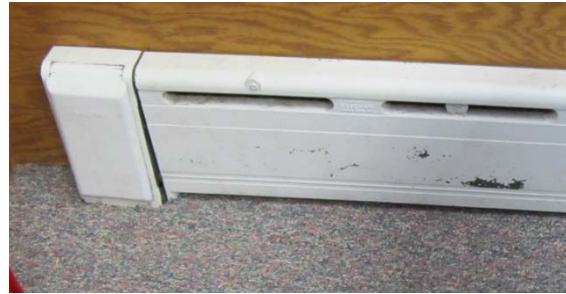
Radiators and heating units with peeling paint can be found in every space of the historic library. Additional equipment in need of some repainting includes water-damaged heaters in the Main stair outside the Youth Reading Room and the Reference Room. The equipment within the heater should be inspected and/or repaired prior to re-painting to ensure that the cause of the water problem has been

eliminated. Other miscellaneous mechanical system issues that need correction include the repair or replacement of one of the floor grills in the South Reading Room (at the east wall) which is falling into the duct. Water stains on the ceiling of the Children's Librarian's Office may be related to dripping mechanical equipment in the attic above.
