Meredith Library

Energy Audit

Prepared for:
Town of Meredith, NH

August 31, 2011

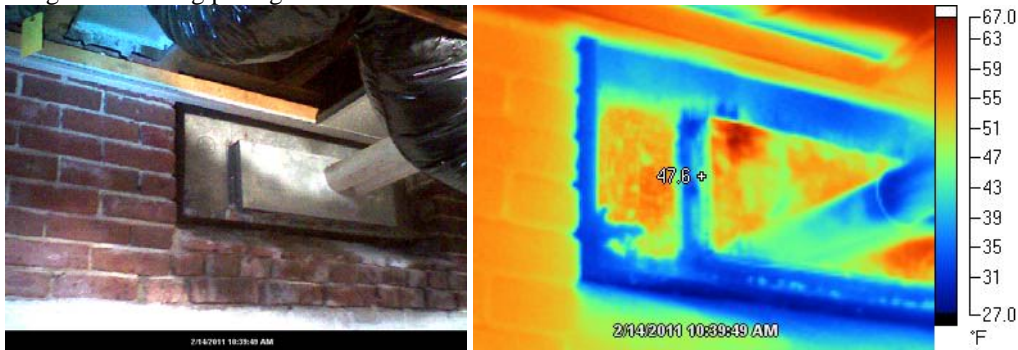
IR002154

1. (B1) The foundation walls and band joists in the basement of the original library are uninsulated. Some of the basement window panes have been replaced with plywood to create passages for plumbing and mechanicals and most of these passages leak. There is also some efflorescence at the back of the building.

Image 1a: Leaking passages

1. (B1) Insulate the foundation walls and band joists down to 1' below the outside grade with open cell foam to at least R20 thickness (about 6") anywhere that the foundation and band joists are accessible. Foam over the plywood passages for mechanicals so they can have better R-value and seal around the penetrations. Most of the penetrations can be sealed in foam but avoid direct contact between the foam and the boiler and space heater flues. These areas should be insulated with fire rated caulk and rock wool instead and then the foam can be sealed to the perimeter of the rock wool. Since this is occupied space ask the foam installer to provide a 15-minute thermal barrier coating over the foam and make sure the coating is approved by the local fire code before installation. Sealing in the basement will improve the overall air tightness and decrease the stack effect for the building as well as increase the R-value of the foundation walls and band joists. We recommend open cell foam in order to allow vapor transfer through the foam and the masonry walls. These masonry walls have allowed two-way vapor transfer for many years and it is probably best to keep it that way to reduce spalling or efflorescence of the brick (the presence of which we noted at the back of the building. Note that relative humidity may increase with an insulated and tight basement.

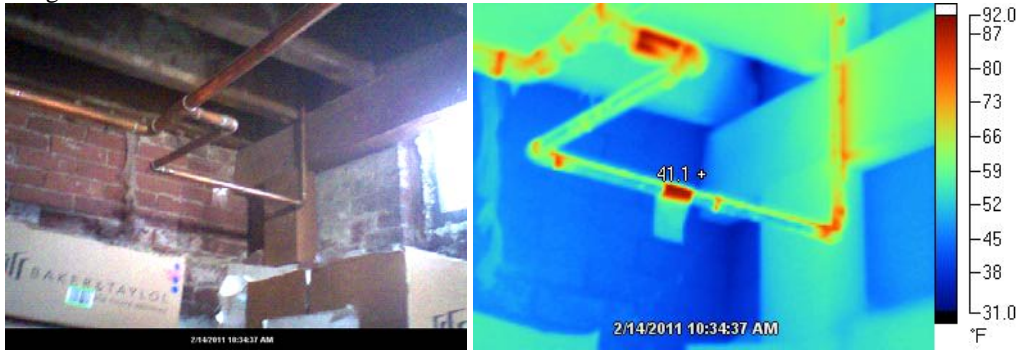
IR002139

Image 1b

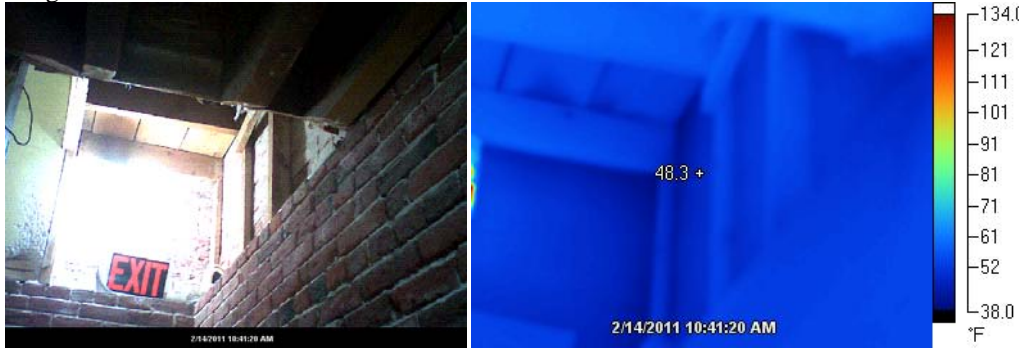
IR002161

Image 1c:

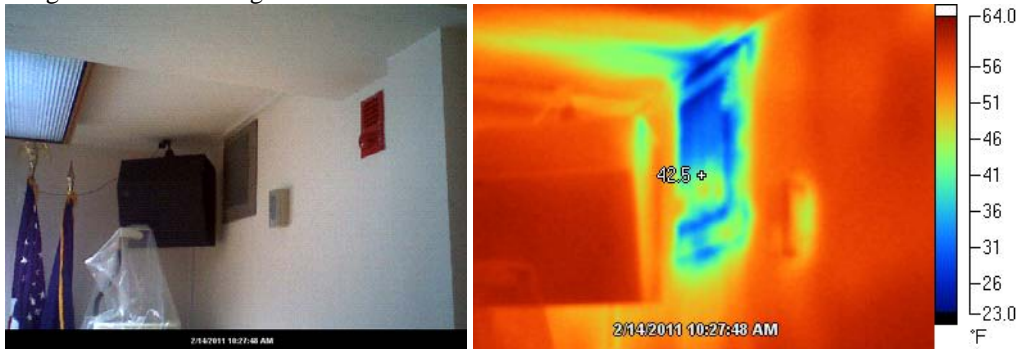
IR002112

2. In the basement level function room there is a ventilation fan in the corner through which cold air enters the building. Water stains on the wall below the fan opening also indicate a possible location for water entry or condensation in addition to air leakage.

Image 2a: Cold entering at ventilation fan location

2. The purpose of the ventilation fan in the basement level function room isn't clear. Nevertheless it should be covered from outside in the winter. Cold dense air enters through this opening to replace warm air that is leaving through higher parts of the building. Blocking this opening will reduce the stack effect in the building. If the fan is rarely used then permanent removal of it should be considered.

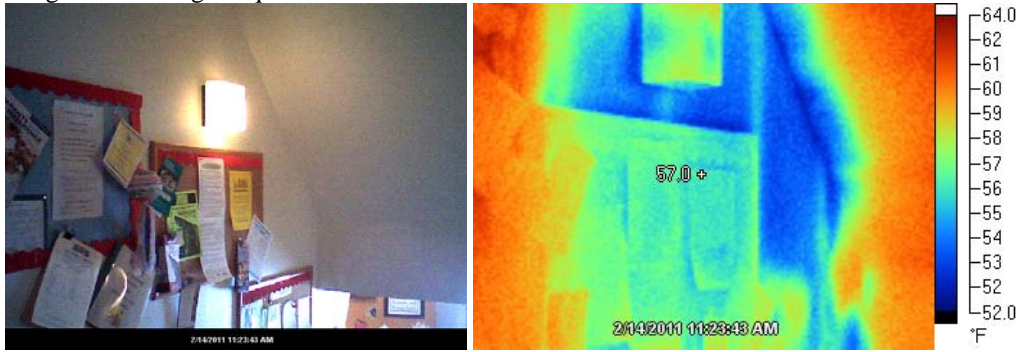
IR002377

3. The above grade walls of the main library 1st floor, 2nd floor young adult section, and the emergency stairs are plaster and wood lathe with wood studs on solid brick. There is no insulation between the wood studs. It was not possible to determine the thickness of the wood studs but the renovation plans show a wall that has a total thickness of 15.” Assuming the solid brick is 12” thick and the lathe and plaster is about 1” thick the balance would be 2” for the thickness of the woods studs.

Image 3a: Lacking adequate insulation in walls

3. (B3) Regarding the above grade walls of the main library 1st floor, the 2nd floor young adult section and the emergency stairs: These walls will be difficult and expensive to retrofit from the inside but if it can be done we recommend using a vapor permeable insulation such as open cell foam. Open cell foam can be installed by injecting it through holes in the wall. Actual cavity thickness will determine the number and spacing of the holes. Coordinate this type of retrofit with repainting of the interior walls as all the books and shelving will have to be masked anyway and the holes in the plaster will have to be patched. If the actual cavity is an inch or less we would instead recommend gutting the walls and reframing them with thicker stud walls to allow for more insulation.

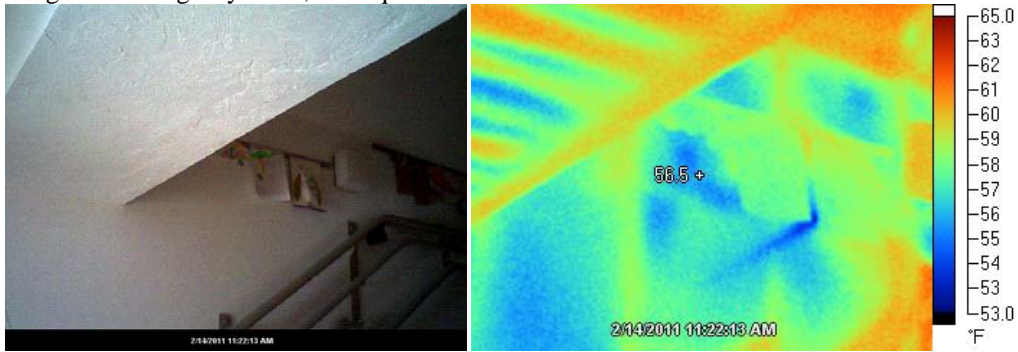
IR002366

Image 3b: Emergency stairs, inadequate insulation

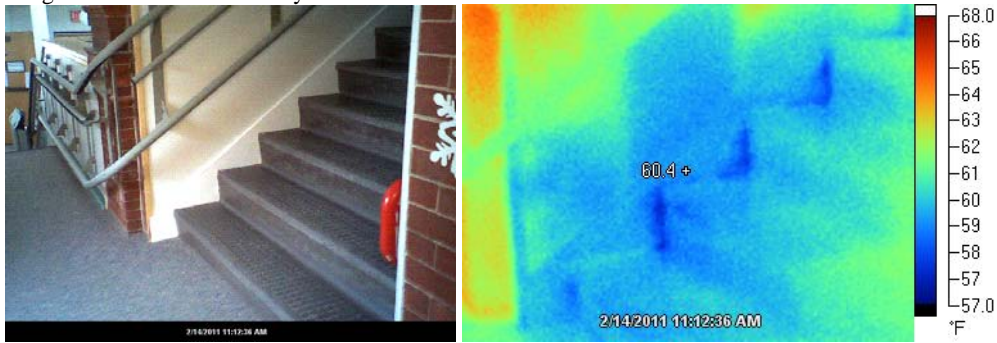
IR002302

4. The walls of the 2nd floor stairway and corridor leading to the children's section have many air leaks. This is a location where the addition meets the original building.

Image 4a: Air leaks in stairway and corridor

4. In terms of the walls in the 2nd floor stairway and corridor leading to the children's section: Improvements in insulation and air tightness will help to improve the area, although the sheetrock would have to be opened up from inside in order to perform the work. This work, if performed, should take place at the same time as the ceiling work in this area, as in #9 below.

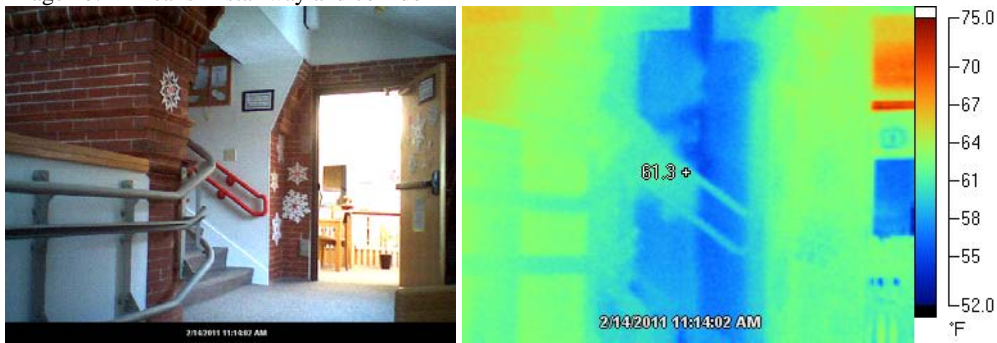
IR002314

Image 4b: Air leaks in stairway and corridor

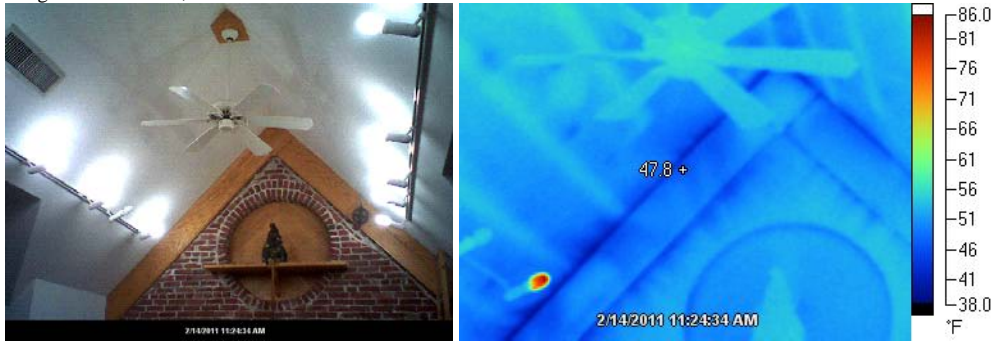
IR002381

5. There is inadequate sealing behind the wood trim at the gable end of the children's section, where the wall meets the ceiling.

Image 5a. Gable end, children's section

5. (B9) Remove the wood trim at the gable end of the children's section so the sheetrock can be caulked to the brick. The contours of the brick and mortar should be carefully followed with flexible caulk in order to make the seal effective. Reinstall the trim once sealing is complete.

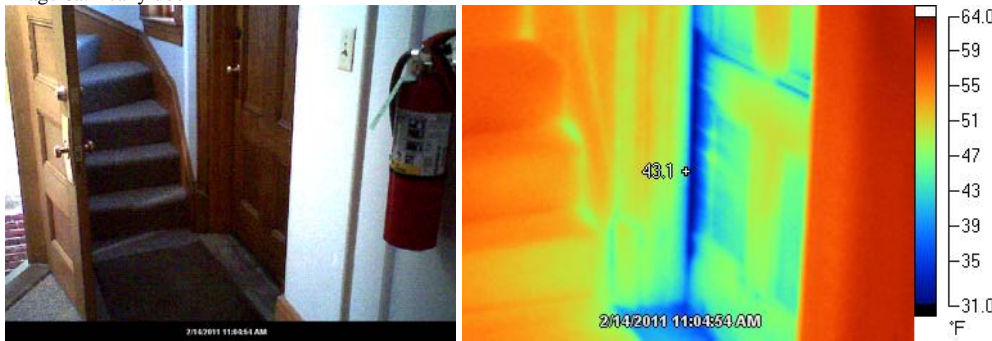
IR002256

6. Many of the exterior doors are lacking sweeps at the door base and there are numerous gaps in the weather-stripped perimeters.

Image 6a: Leaky door

6. (B11) Repair weather stripping on all sides of exterior doors. For the best fit on newer doors contact the door manufacturer to get replacement weather-stripping. A properly weather stripped door will have no daylight visible at the perimeter when closed. Focus particular attention on doors that are rarely used so they can be made as airtight as possible.

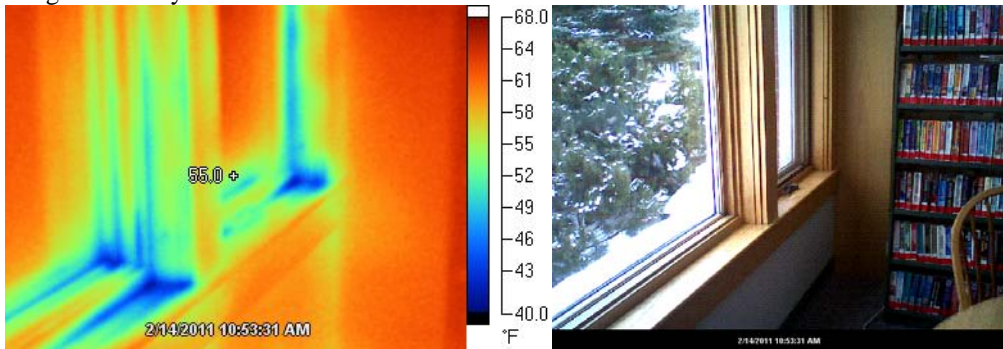
IR002203

7. The windows in the addition are mostly double pane, gas filled, wood framed windows with aluminum spacers. The windows typically leak at the wood trim. The addition plans show foam sealant between the window frames and the rough openings but it may not have been installed or it doesn't appear to have worked because most of the addition windows leak at the trim.

Image 7a: Leaky windows

7. (B9) For windows on the main levels of the building start with the worst, such as the clerestory window by the stairs to the children's section, and remove the trim to see if the seal between the window frame and the rough opening can be resealed with foam and then reinstall the trim. If this test window indicates that other windows may not have been foam sealed originally then this method can be repeated on the other windows. Because this action is labor intensive and the energy savings will be modest for sealing air leaks, and alternative approach would be to seal all the wood trim joints with clear or white caulk. This will not be as effective as foam sealing between the window frame and the rough opening, but it will be a much easier installation.

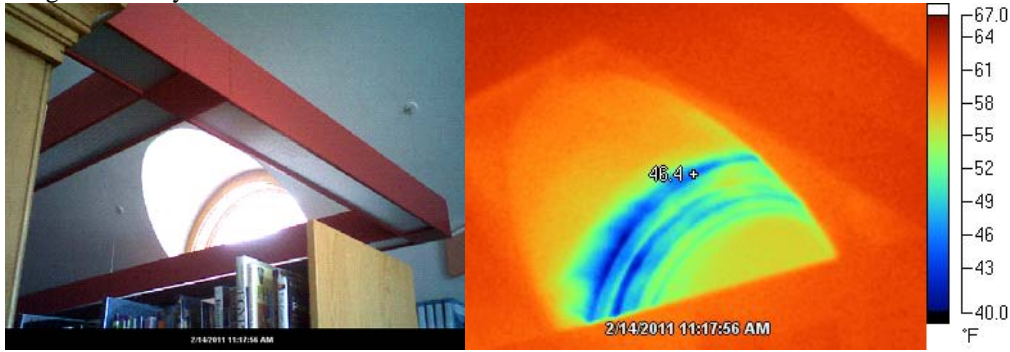
IR002342

Image 7b: Leaky windows

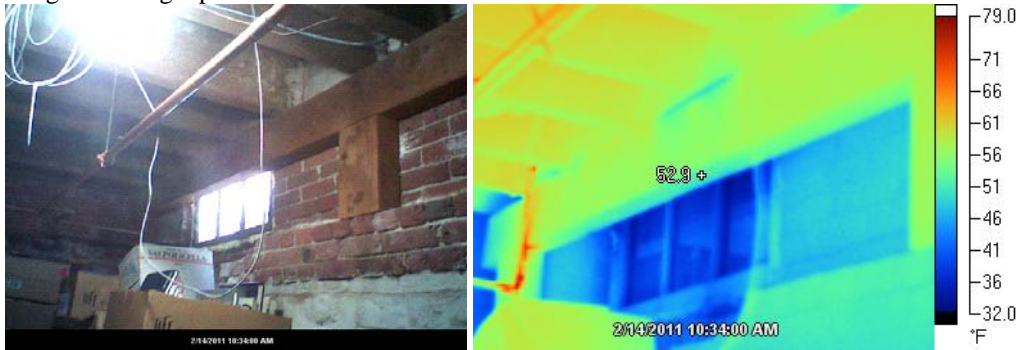
IR002134

Basement windows are single pane resulting in a low R-value. Some of the windows are partially blocked so the daylight they provide to the basement is minimal.

Image 8a: Single pane basement windows

8. (B10) Install exterior storm windows over the basement windows to increase air tightness and R-value. Use tempered glass to help protect the windows against snow and ice from the roof. Some of the windows are partially blocked by wood framing so the daylight they provide to the basement is minimal. Consider covering those windows from inside with plywood painted black and then insulate behind them with at least R-15 of rigid foam board. Foam seal the insulation in place so warm air can't get around the insulation. This will make the windows act more like walls in terms of R-value.

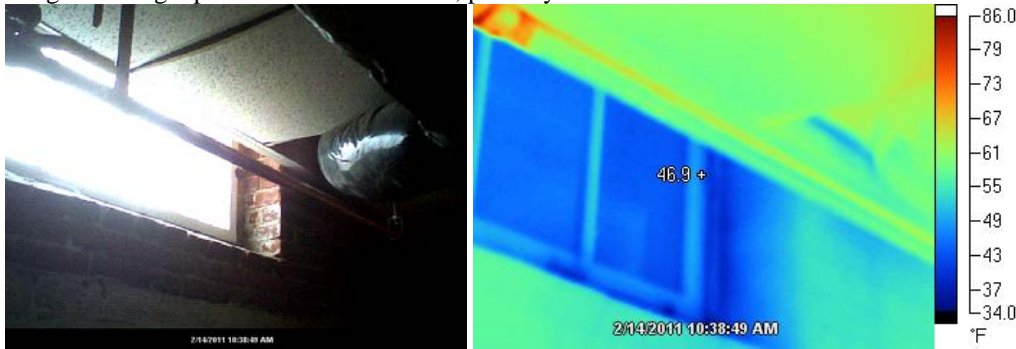
IR002147

Image 8b: Single pane basement windows, partially blocked

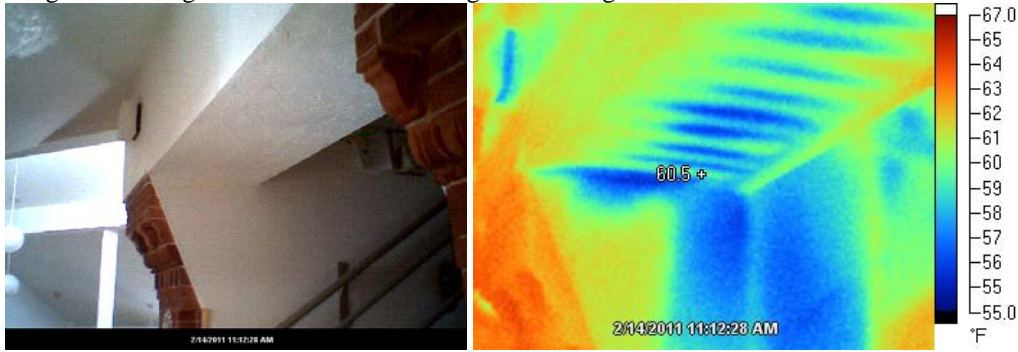
IR002301

8. The ceilings of the 2nd floor stairway and corridor leading to the children's section have many air leaks. This is a location where there are many changes in the roof plane where the addition meets the original building. It appears that cold air is being allowed into the walls and ceilings where the new roof partially covers the original roof. The plans also show a skylight above the corridor that is not there. In the location where the skylight should be the vaulted ceiling is cold indicating that insulation is missing. This area corresponds to a roof area where ice dams frequently form.

Image 9a: Ceiling where addition meets original building

9. (B4) In terms of the ceilings in the 2nd floor stairway and corridor leading to the children's section: Improvements in insulation and air tightness will help to reduce (but may not eliminate) the formation of ice dams. These spaces do not appear to be accessible from inside the attic, therefore the sheetrock would have to be opened up from inside in order to perform the work. (Also see #4 above.)

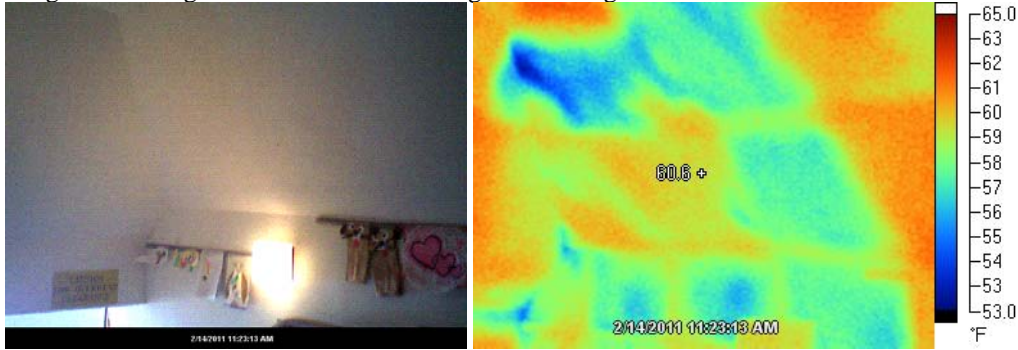
IR002372

Image 9b: Ceiling where addition meets original building

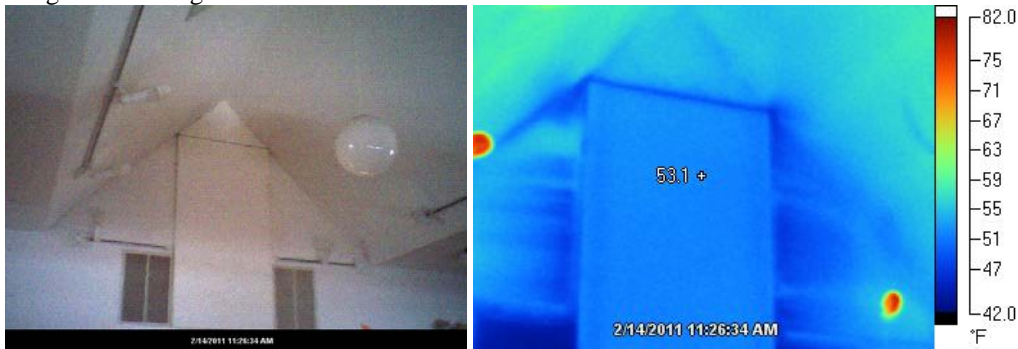
IR002393

9. The attic over the young adult section has only 6” of cellulose over a lathe and plaster ceiling. There is HVAC equipment and ducts in this attic. The attic hatch is uninsulated and has no weather stripping and the wall between this attic and the children’s section is poorly insulated, some of the batts are falling off the wall. This attic space and its connections to the adjoining attic over the children’s section will be complex to remediate.

Image 10a: Young adult section

10. (B8) Because there is so much mechanical equipment and ductwork in the attic, an option for remediation is to insulate in the plane of the roof with open or closed cell spray foam and bring the mechanicals into semi-conditioned space rather than cold space. However, this approach requires that the attic be separated from the cold (and inaccessible) attic over the children's section and will also require the foam to be covered with a 15 minute thermal barrier for fire protection which increases the expense considerably.

11. (M1) Alternatively, because of the complexity of the space we recommend keeping this a cold attic but with the following improvements: Remove the flex duct in this attic and install hard ducts with copious amounts of duct mastic at every joint. Use much more mastic than suggested – our experience is that when applied in typical amounts the joints still leak. Insulate the ducts with R-11 or better, and insulate the mechanical equipment if possible. Air seal all electrical and plumbing penetrations through the lathe and plaster with can foam. Use rigid and can or spray foam to reinsulate the common wall that separates the children's section from the attic to create an airtight wall of at least R-20. Insulate and weather strip the attic hatch to at least R-20 as well. Add additional cellulose up to a total R-value of 50.

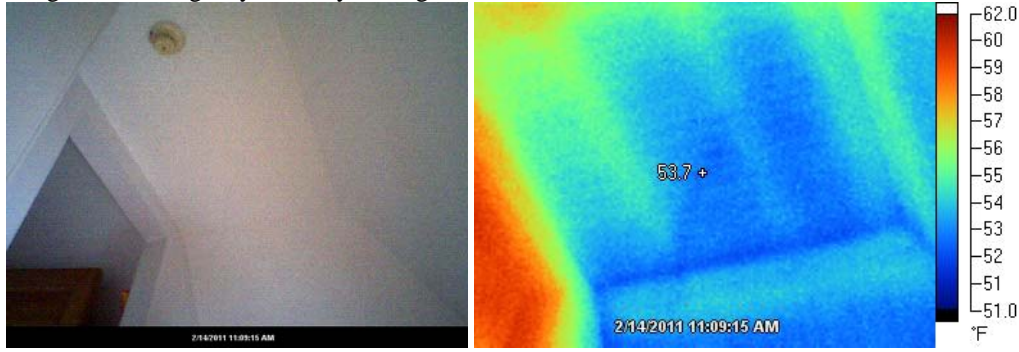
IR002282

10. The ceiling over the emergency stairway in the main library is uninsulated.

Image 11a: Emergency stairway ceiling

12. (B4) Remediating the uninsulated ceiling over the emergency stairway call for the same recommendations as above, #3, for the above-grade walls.
13. The hole in the ceiling of the second floor storage area is easily repaired with foam sealant. However, work on the remainder of that ceiling area would be too costly to justify, unless there were other reasons to make repairs to that part of the roof or ceiling.

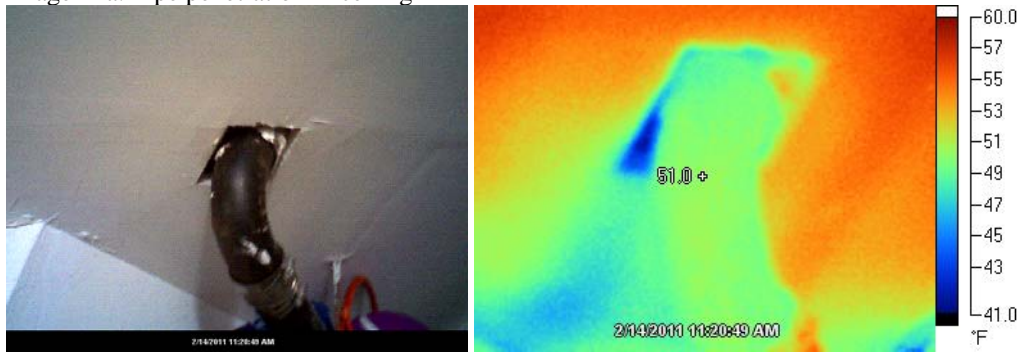
IR002364

11. The ceiling over the connector between the main library and the new addition has many gaps in the insulation. There is also a hole in the ceiling of the second floor storage area for a pipe penetration.

Image 12a: Pipe penetration in ceiling
