Historic Building Conditions Assessment
Meredith Public Library
Meredith, New Hampshire

Norman E. Larson, AIA

April 24, 2012

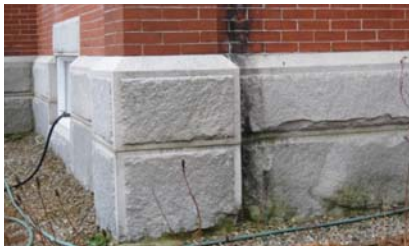
Foundation

The existing stone foundation of the main block of Benjamin M. Smith Memorial Library is in good condition. The stones of the three sides of the building which can be seen from the street are of rock-faced granite with dressed margins and sloping watertable. The joints are

tight and the stones show little sign of movement. The rear block foundation is also of stone but quite low to the ground and without the dressed margins. This area of the foundation

is subject to additional splash back, especially as both the south and west sides of the building are paved right up to the foundation. This rear part of the foundation should be re-pointed and the joint with the brick masonry above caulked. The extra water impacting the system here is the likely cause of the mortar damage at the building's interior behind the stone.

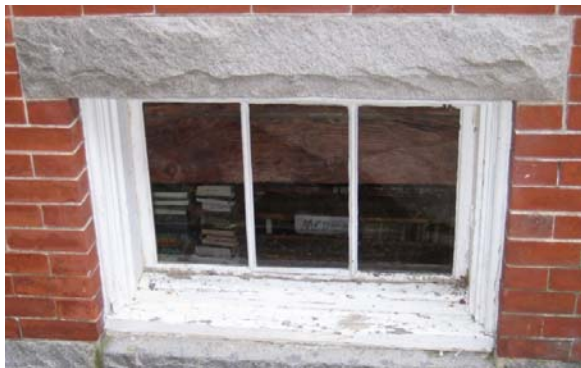
The exterior of the windows, with the possible exception of the first floor sashes themselves, are in need of scraping and painting, especially within the enclosure of the storm window units, though these areas are protected by the storm windows to some degree. The awning windows of the basement are in the worst shape of any windows exposed to the weather with bare

repair following the removal of the original bookcase to its south. Damaged window sills should be sanded down by hand to bare wood and along with any new wood, finished with a clear urethane finish. If the library does not have any record of testing the interior clear finish (varnish) for lead, this should be accomplished before proceeding with any sanding of such finishes.

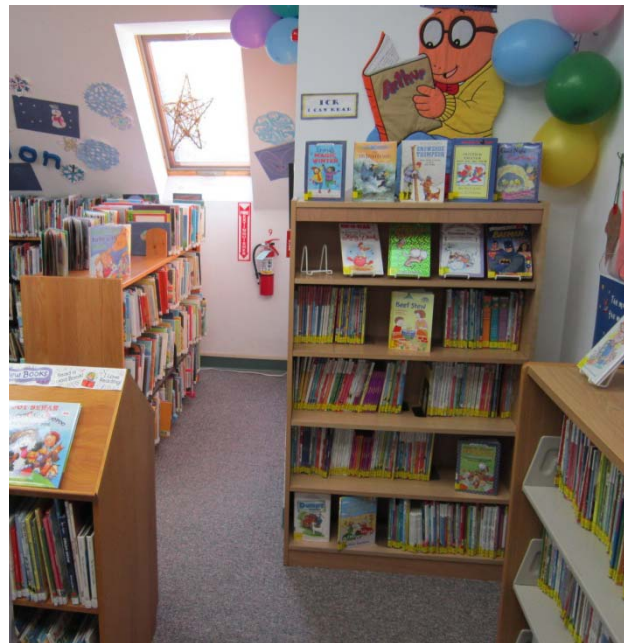
Improve Egress to the Back Stair

Making the modifications suggested to the back stair of the Benjamin M. Smith Memorial Library will make the library safer than it is today. Other changes within the library spaces would also positively impact the safety of the building users. Furniture in the top floor Children's Room should be arranged to provide at a minimum 30" of width around and between the fixed bookcases and tables. Currently this space is reduced to as little as 23 ½" between at the southwest corner of the room near the egress stair enclosure. 36" of width would make the space more accessible to those with mobility limitations. The door to the back stair was relocated during a previous renovation to keep the door from sweeping over the stairs going down. Since it is existing, the 30" door is wide enough but the bottom of the door has been raised to about 1.5" above the floor. The historic door should be re-hung to eliminate the wide gap at the floor.

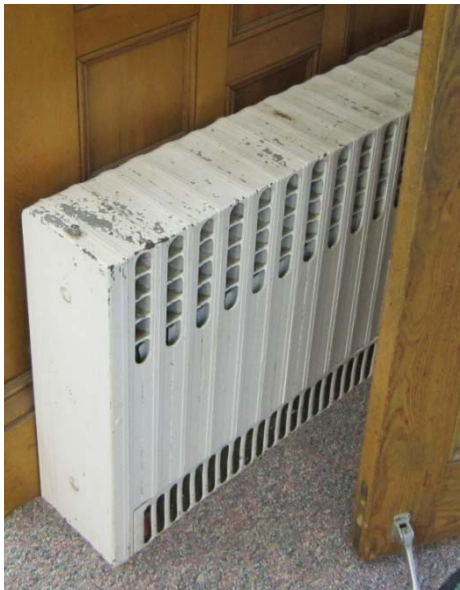
There appear to be several overlapping heating systems in the Benjamin M. Smith Memorial Library, some of which may no longer be functioning or necessary. Cast iron baseboard radiators throughout the library have paint failures such as peeling and cracking. Radiators that are no longer in service may be removed from the building and holes through the baseboards filled with wooden plugs to match the existing woodwork to the greatest degree possible. Likewise, if the mechanical enclosure at the southeast corner of the Young Adult's Room is no longer necessary, it should be removed. Any of these appliances installed in the library prior to 1972 were likely finished with lead based paint, though this may have been previously abated. Flaking or peeling paint on items to remain should be removed in a lead-safe manner, and the metal primed and painted as appropriate with a heat -tolerant paint manufactured for use on mechanical work.

Radiators and heating units with peeling paint can be found in every space of the historic library. Additional equipment in need of some repainting includes water-damaged heaters in the Main stair outside the Youth Reading Room and the Reference Room. The equipment within the heater should be inspected and/or repaired prior to re-painting to ensure that the cause of the water problem has been
