Meredith Library

Energy Audit

Prepared for:
Town of Meredith, NH

August 31, 2011

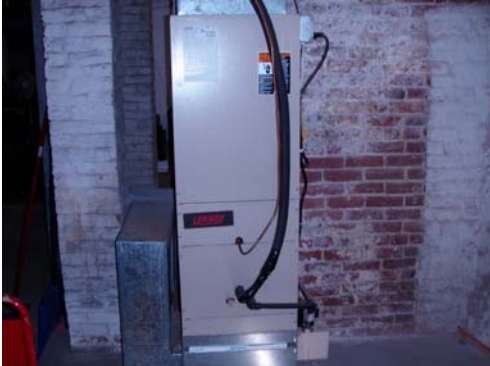
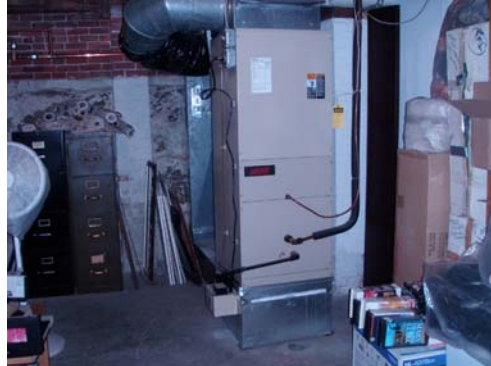
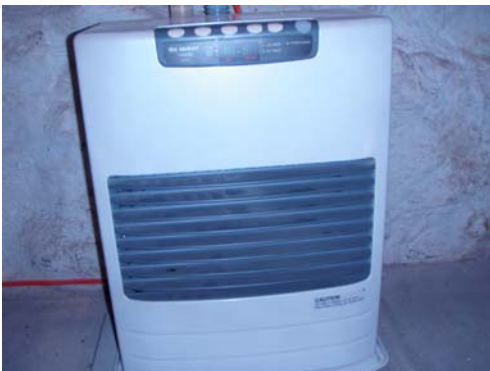
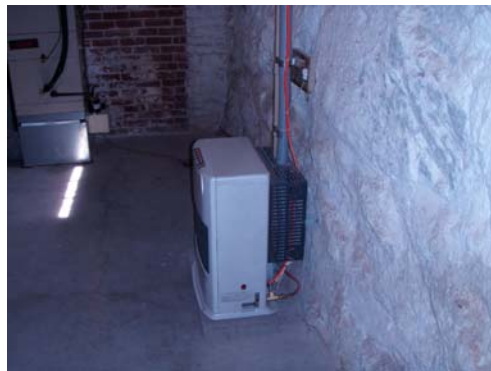
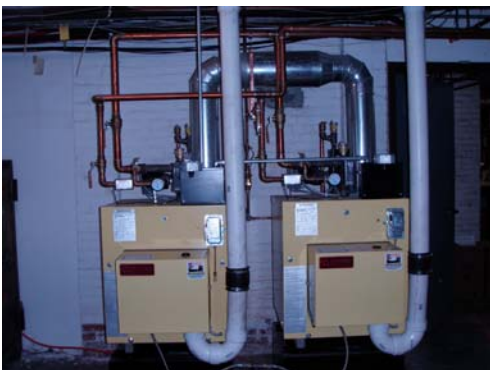
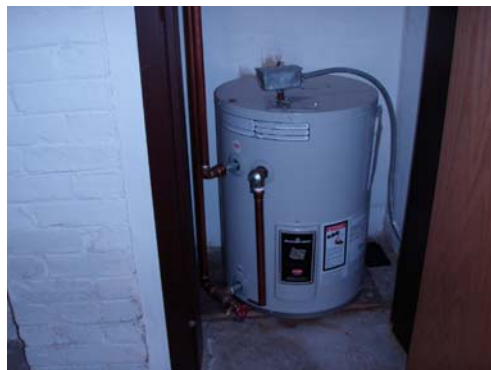
Existing Conditions

The existing HVAC system was replaced when the renovations were done in the mid 90's. It is a hydro-air system with 2 sealed combustion, low-mass, oil fired boilers. Energy Kinetics, System 2000. These boilers supply hot water to airhandlers which are distributed throughout the building to reduce duct runs and enable zoning. Each air handler is also equipped with a DX coil for Air conditioning. These coils are supplied with coolant from the condensing units outside the building. There is also supplemental cast iron baseboard and panel radiation for heating and a small unit heater in the unfinished basement work area. The new work also utilized a few minisplit AC unit's to handle areas where ductwork was hard to place.

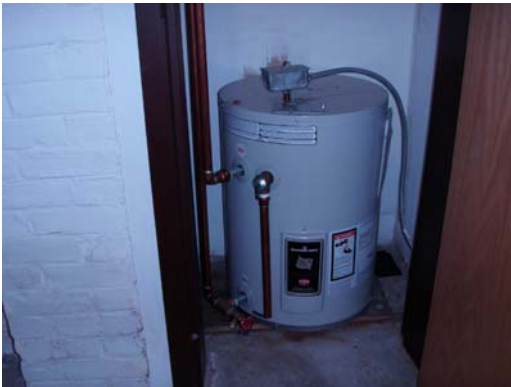
DOMESTIC HOT WATER

Domestic hot water is currently supplied by a small electric hot water heater that is located in a closet in the basement. When this unit reaches the end of its useable life, it should be replaced with small point of use units located at the sinks. These units should be a Marathon or Bosch type. This will reduce standby losses and losses that occur with distribution. This is usually calculated to be around 10-15% of total hot water energy use.
